TECHNICAL INSPECTION REPORT

OPERATION CROSSROADS. U.S.S. INDEPENDENCE (CVL 22)

TEST ABLE.

VOLUME 2 OF 4 [10]

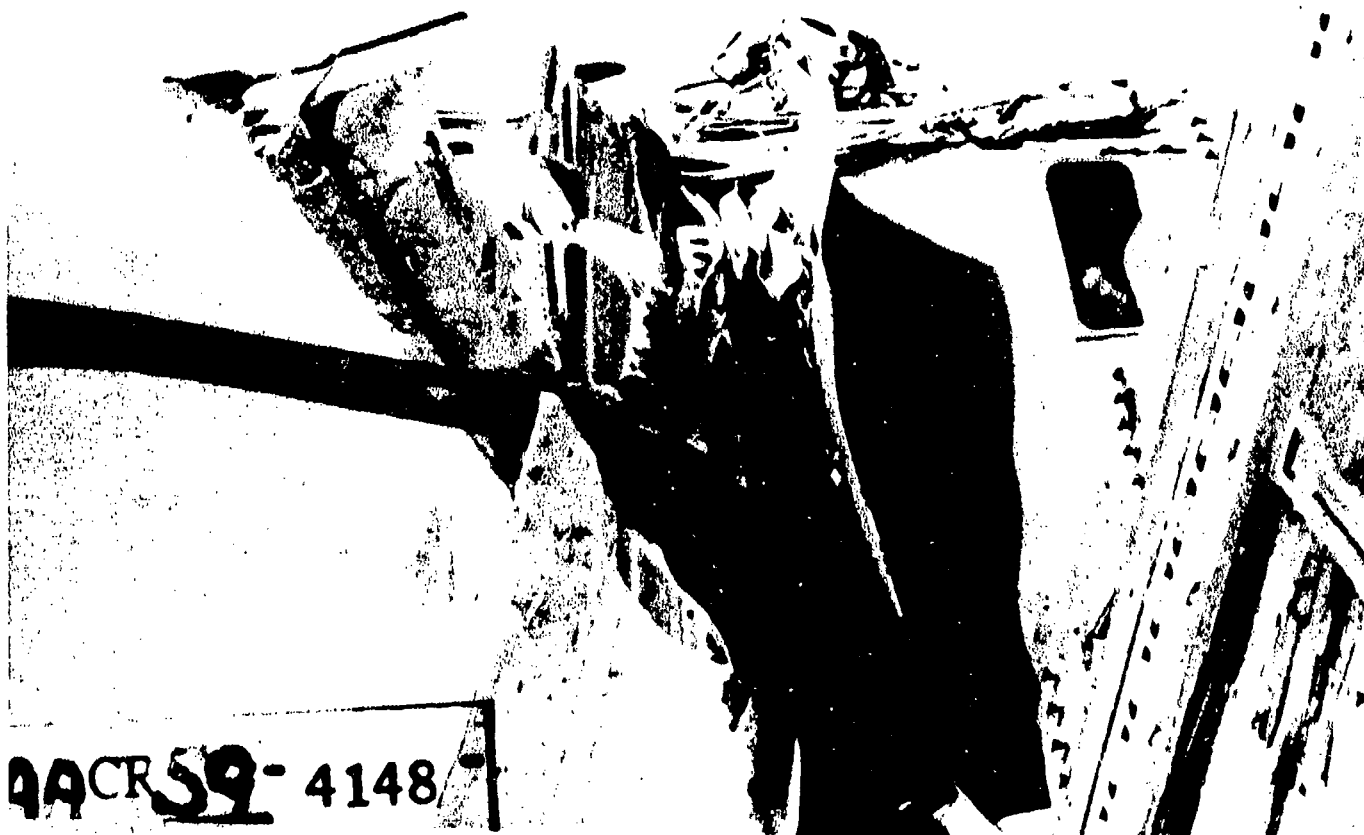
AA-CR-59-4148-3

AA-CR-59-4148-3. Flight deck. Void in way of missing aft port corner.

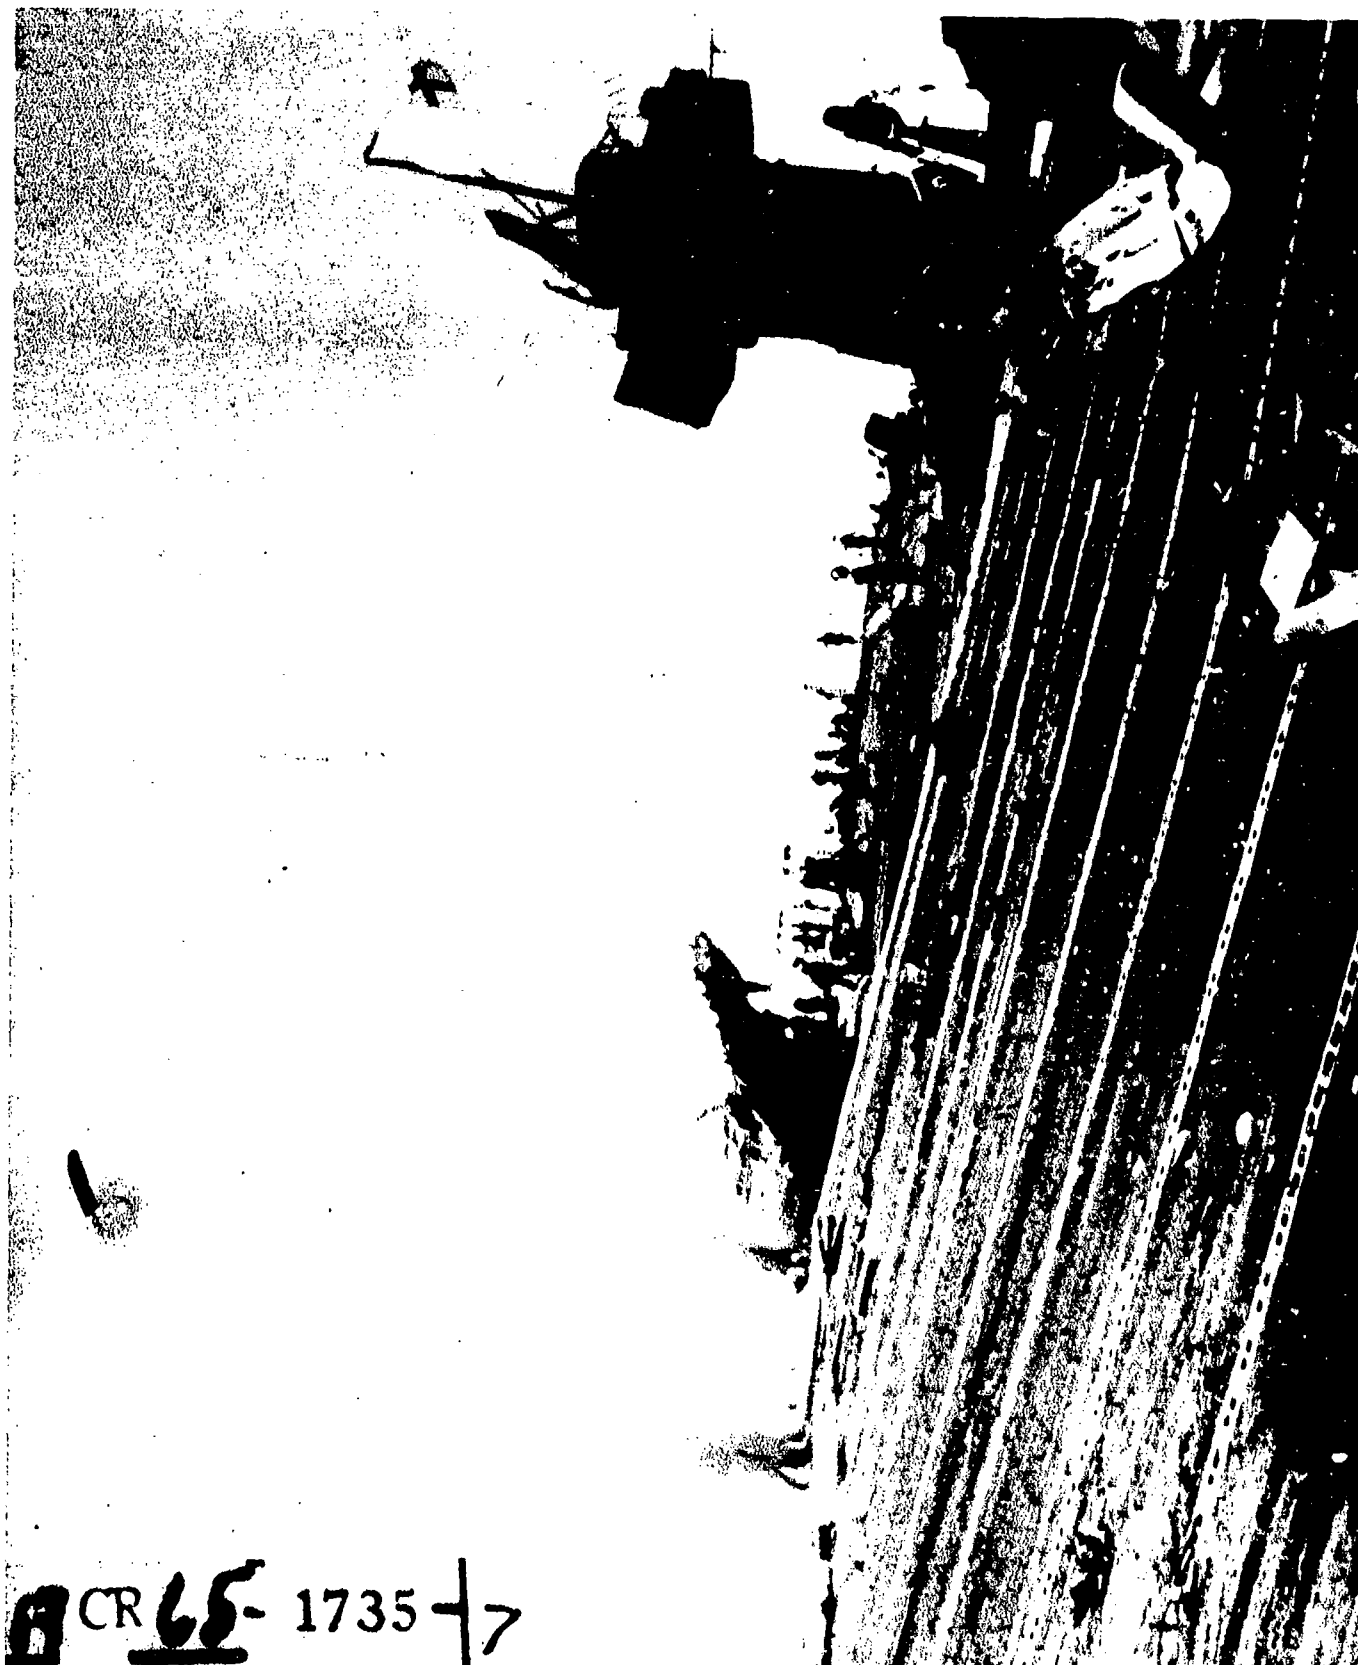
AA-CR-65-1735-7

AA-CR-65-1735-7. Starboard side of flight deck. Looking forward from amidships.

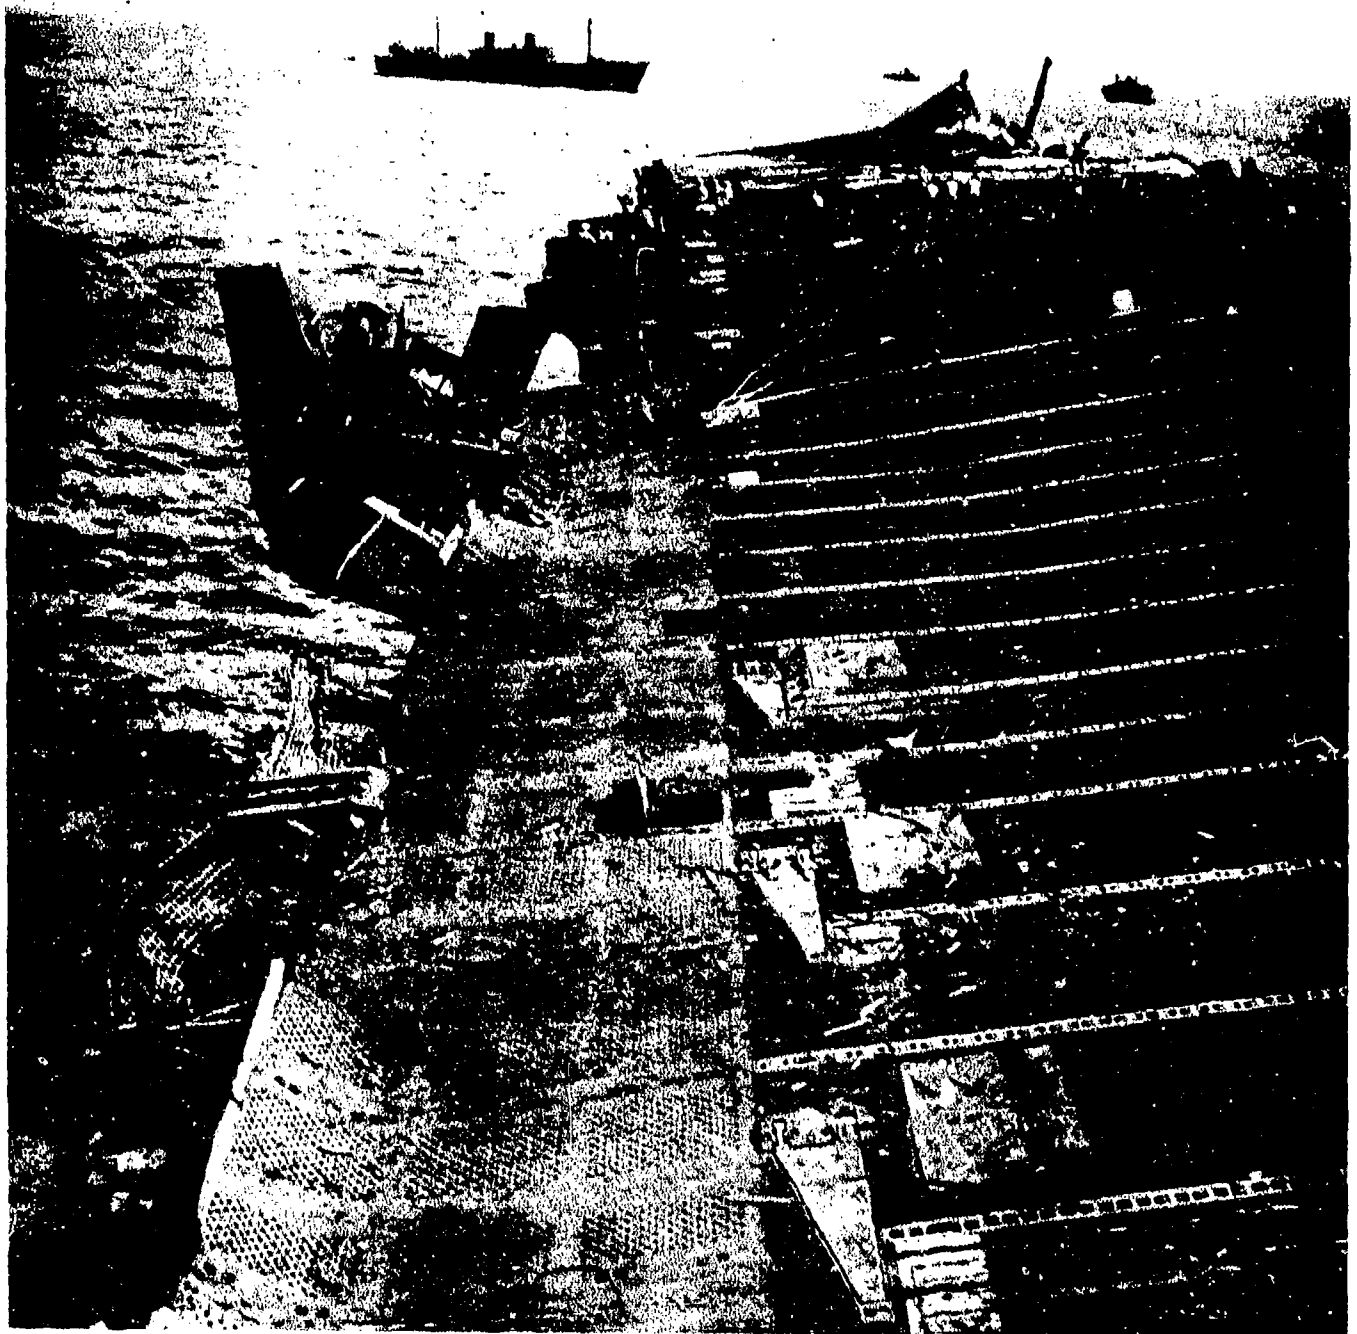
AA-CR-59-2166-1. Looking aft along starboard side of flight deck.
Taken from air defense level showing No. 3 and 4 smoke stacks.

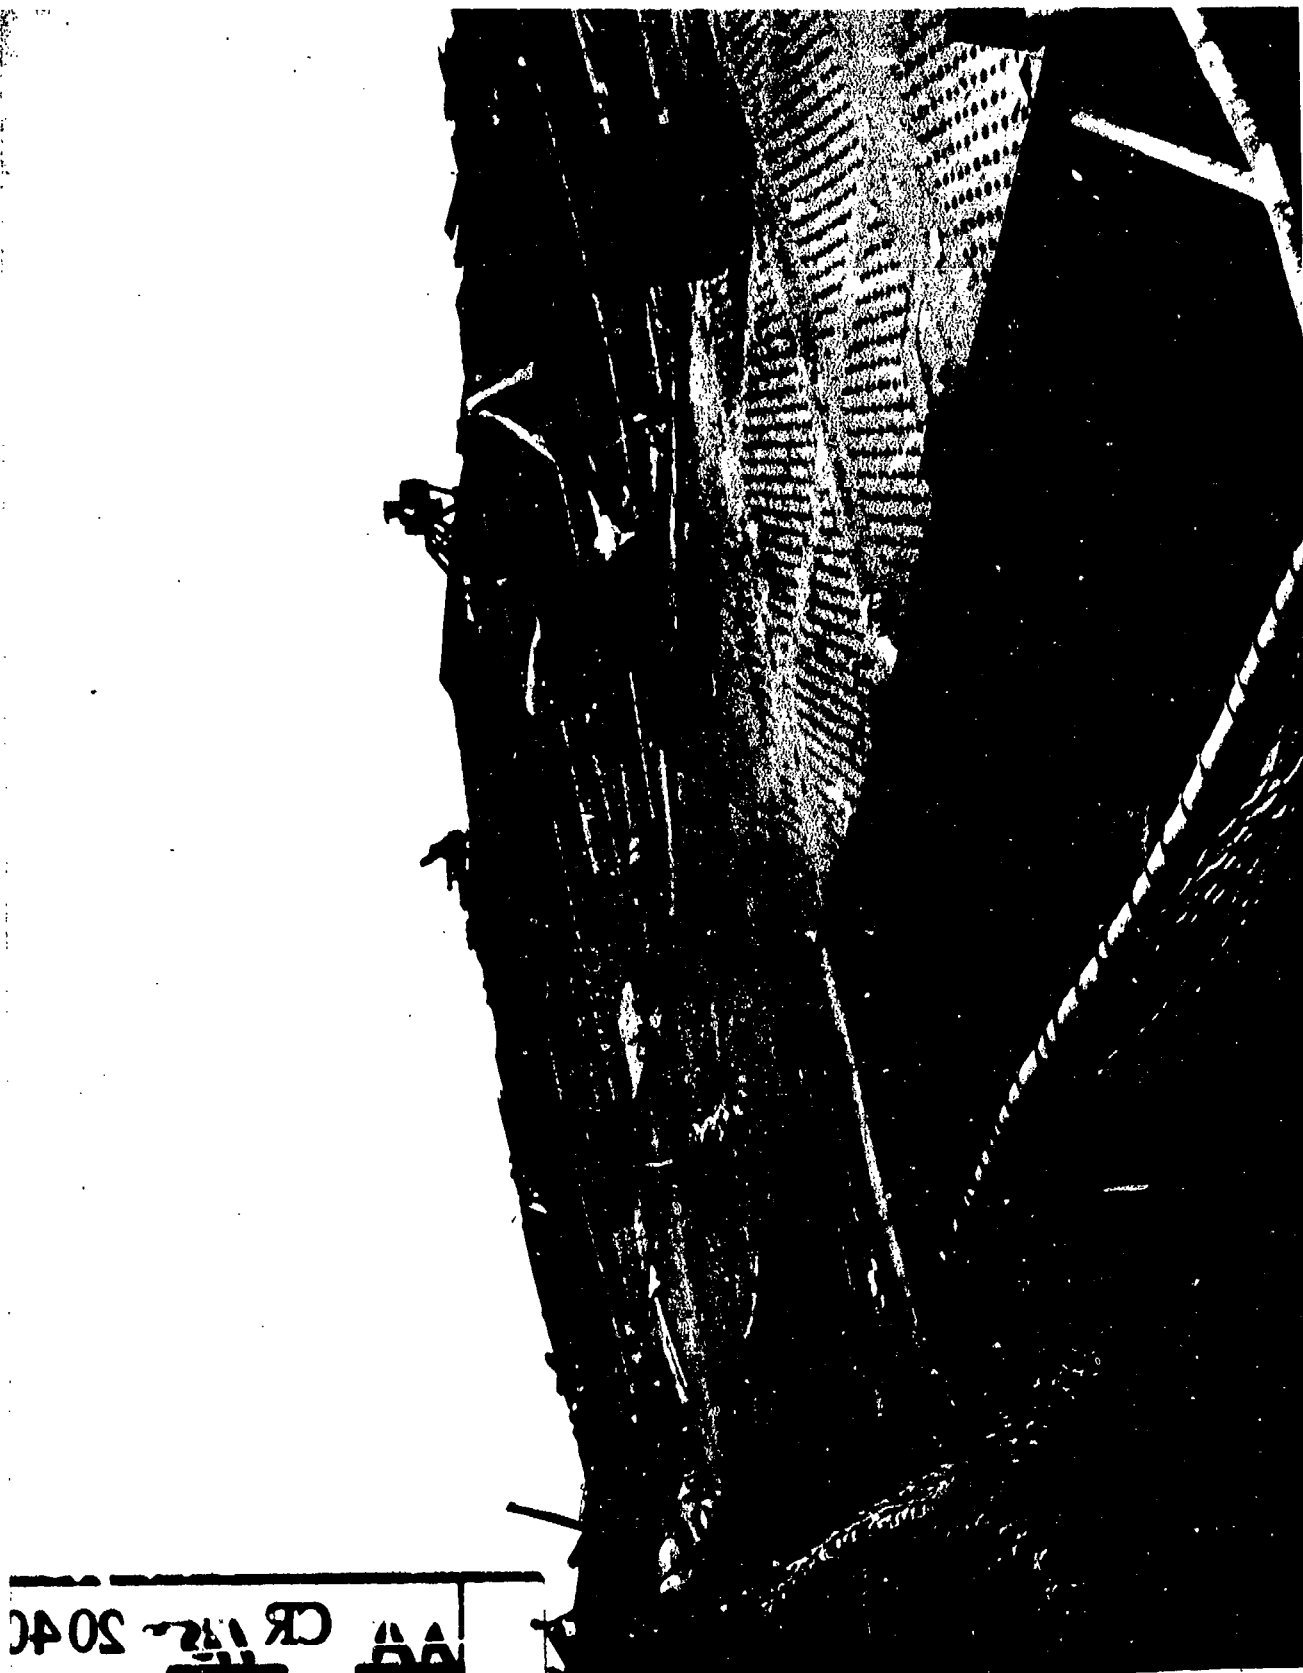
AA-CR-175-2040-8. General view looking aft on flight deck from frame 67. Open hatch, right center, is at frame 70.

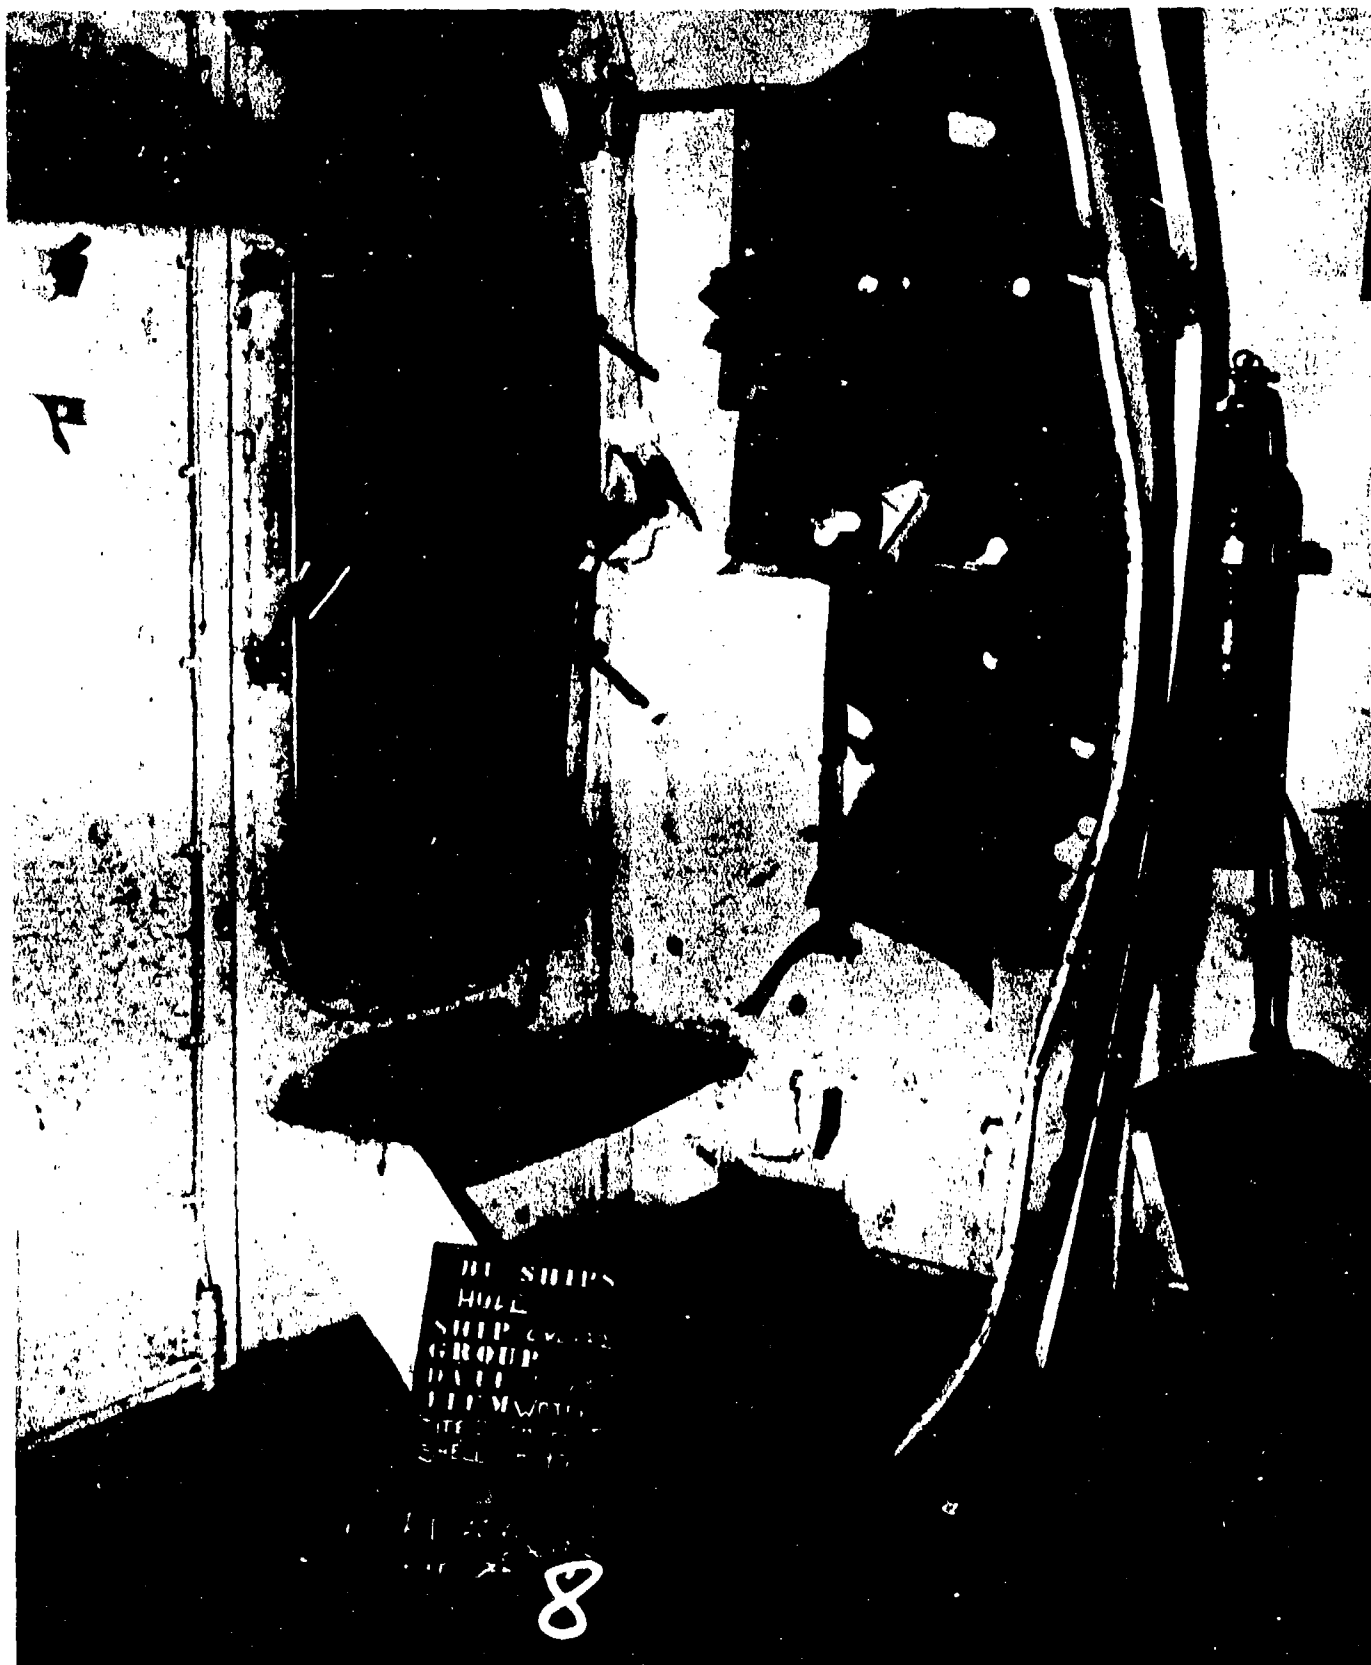
AA-CR-88-2100-8. Gallery level door in port shell from aviators ready room. Looking to port and forward at bulkhead 39.

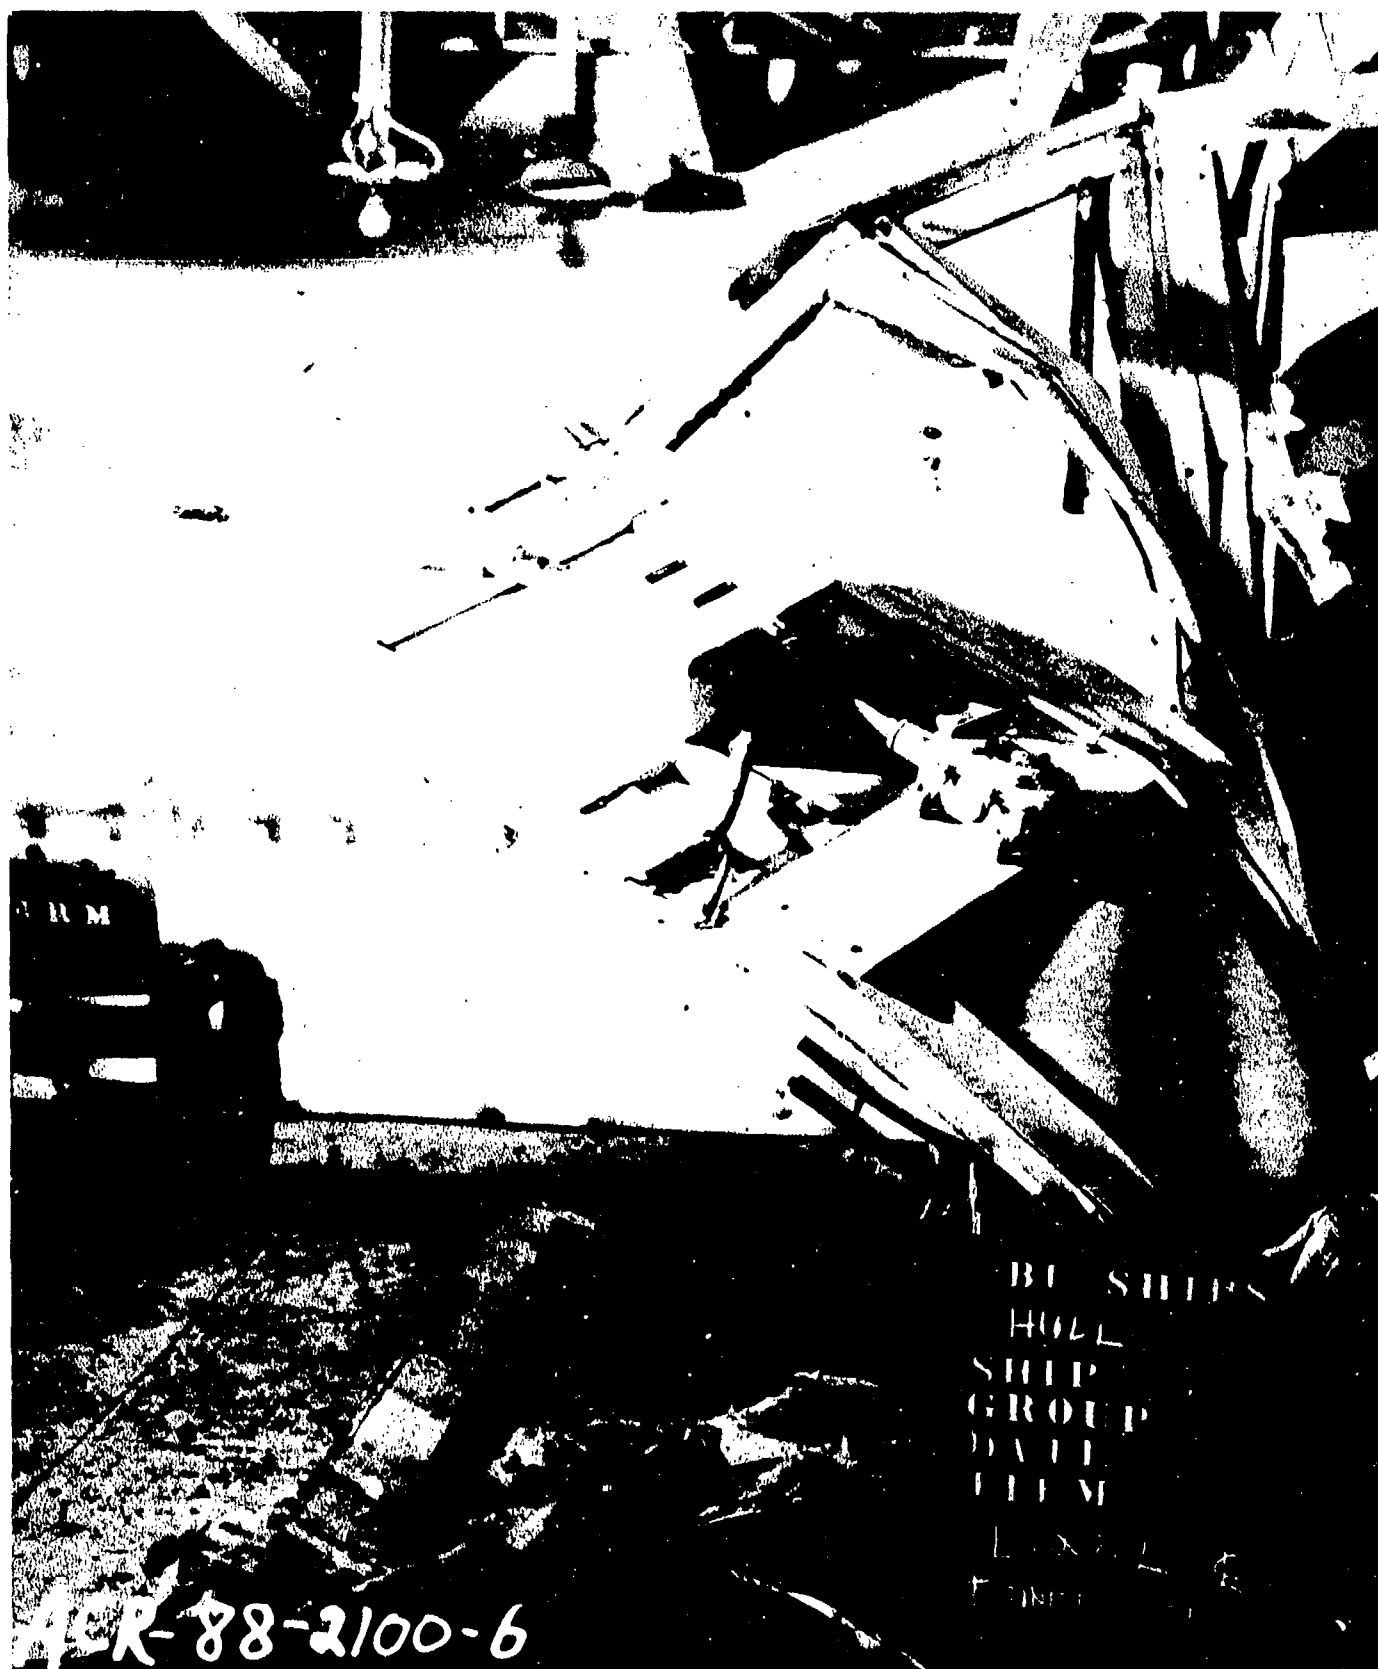
AA-CR-88-2100-6. Gallery deck, inboard joiner bulkhead, aviators ready room, frame 42. Looking forward. Bulkhead deflected towards blast.

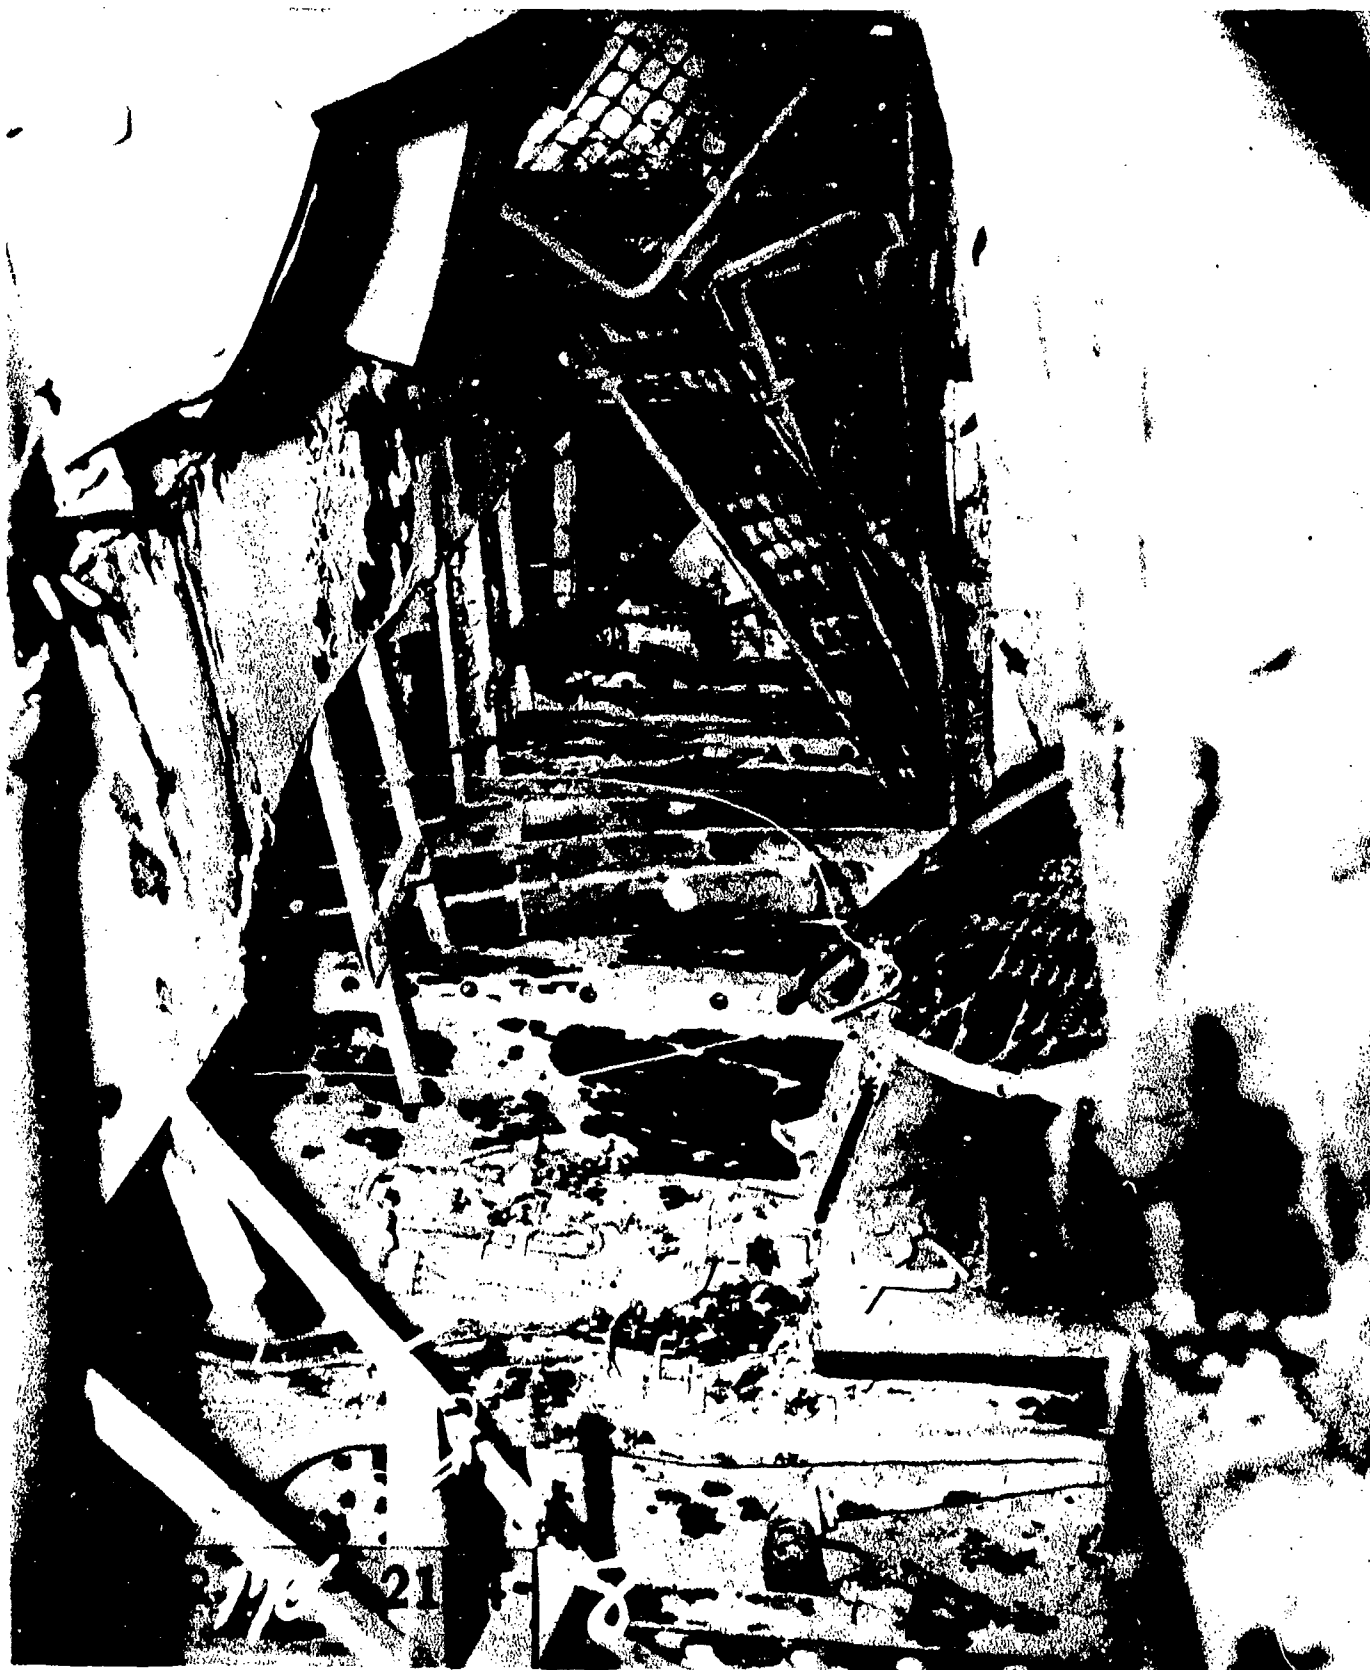
AA-CR-175-2114-8. Poop deck, looking to starboard along after face of bulkhead 132 from opening in port shell. Debris in crew's berthing space.
